Service Bulletin

Bulletin No.: 21-NA-074

Subject: Malfunction Indicator Lamp Illuminated On Driver Information Center (DIC) with DTC P0300 and/or P0299/P2227 Set

Brand:	Model:	Model Year:		VIN:		Engine:	Transmission:
		from	to	from	to		
Buick	Envision	2016	2020	-	-	Equipped with 2.0L Engine (RPO LTG)	All

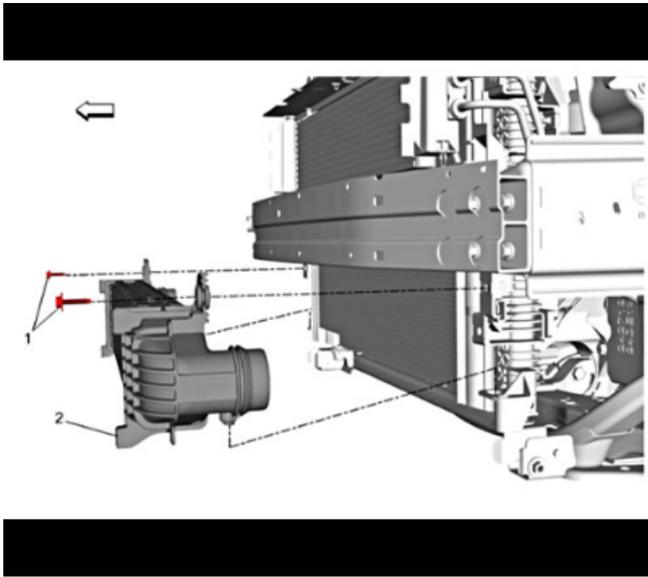
5779438

Important: The latest designed charge air cooler is wider, as shown in the picture above, and is NOT compatible with the existing lower baffle on vehicles built BEFORE January 5, 2019. The baffle will need to be replaced to accommodate the larger charge air cooler if the charge air cooler is being replaced
